1234 Home Inspection Lane, Cardington, OH 43315

# Home Inspection Report

Richie Burkhardt / E&R Premier Inspections

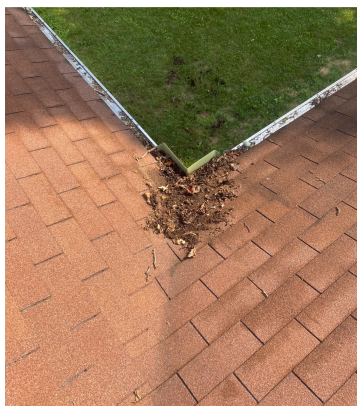
3.1 TYPE

DESCRIPTION: Gable

Recommend having the valleys and gutter guards cleaned to prevent any damage to the roof and allow the water to drain off

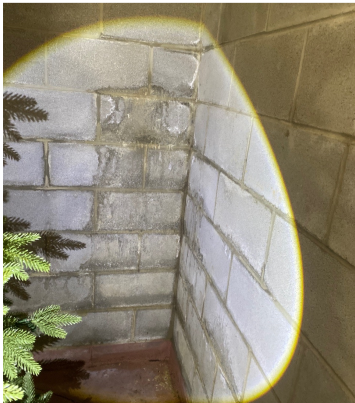
5.2 FOUNDATION

Block wall appears to have add water infiltration previously. Recommend keeping a watch on the wall and if leak proceeds, have a contractor evaluate and repair.

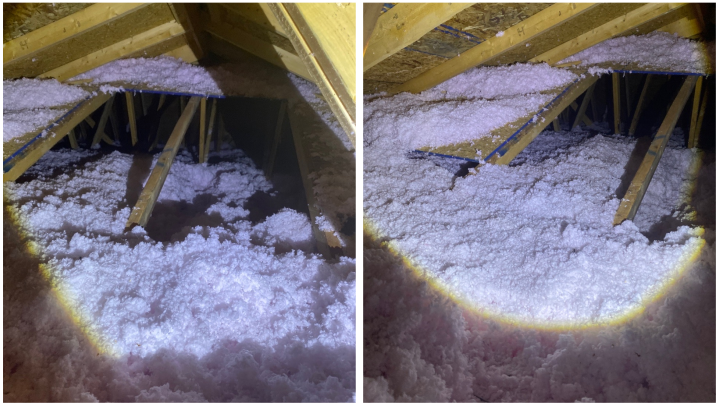
8.3 INSULATION

DESCRIPTION: Blown in

DEPTH: 12 inches

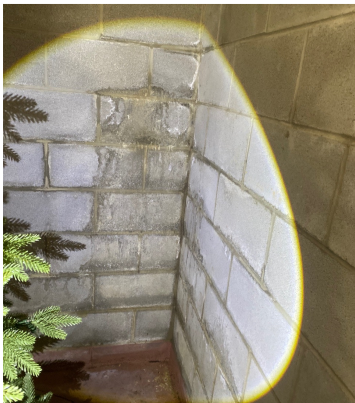
9.3 WALLS

Advise keeping watch on this area looks to have had water intrusion previously. If noticeable water leakage occurs, should contact a licensed contractor to repair.

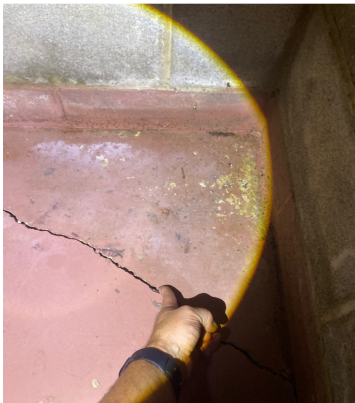
9.5 FLOORS

Concrete slab looks to have settled in the corner, possibly from right after build. Advise caulking, crack, and monitor if crack widens recommend contacting a licensed building contractor for repair

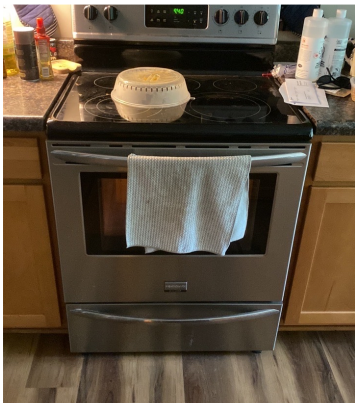
13.7 RANGE/OVEN

DESCRIPTION: Frigidaire

Recommend installing an anti-tip bracket
